# Krauss gas inlet problem

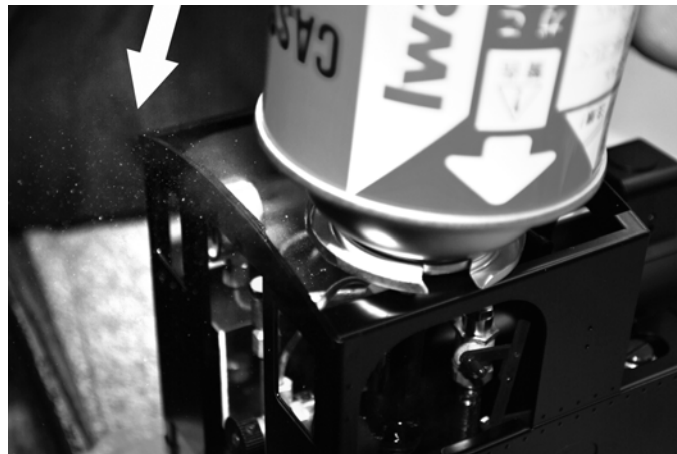
Krauss gas inlet has a problem with the center pin, because it moves from side to side during gas charging. For this part we used a readily available item and we found, during gas charging gas leaks out from the inlet pin sides. You can see this in the photo on right side marked with an arrow.

To stop the side movement of the center pin, please insert the O-ring supplied (PN1-1) around the center pin as per below diagram.
